Overtaken timber lorry Machine and environmental damage

March 2017 (Ref 17.07)

Created by, Scottish Woodlands Compliance Support Team

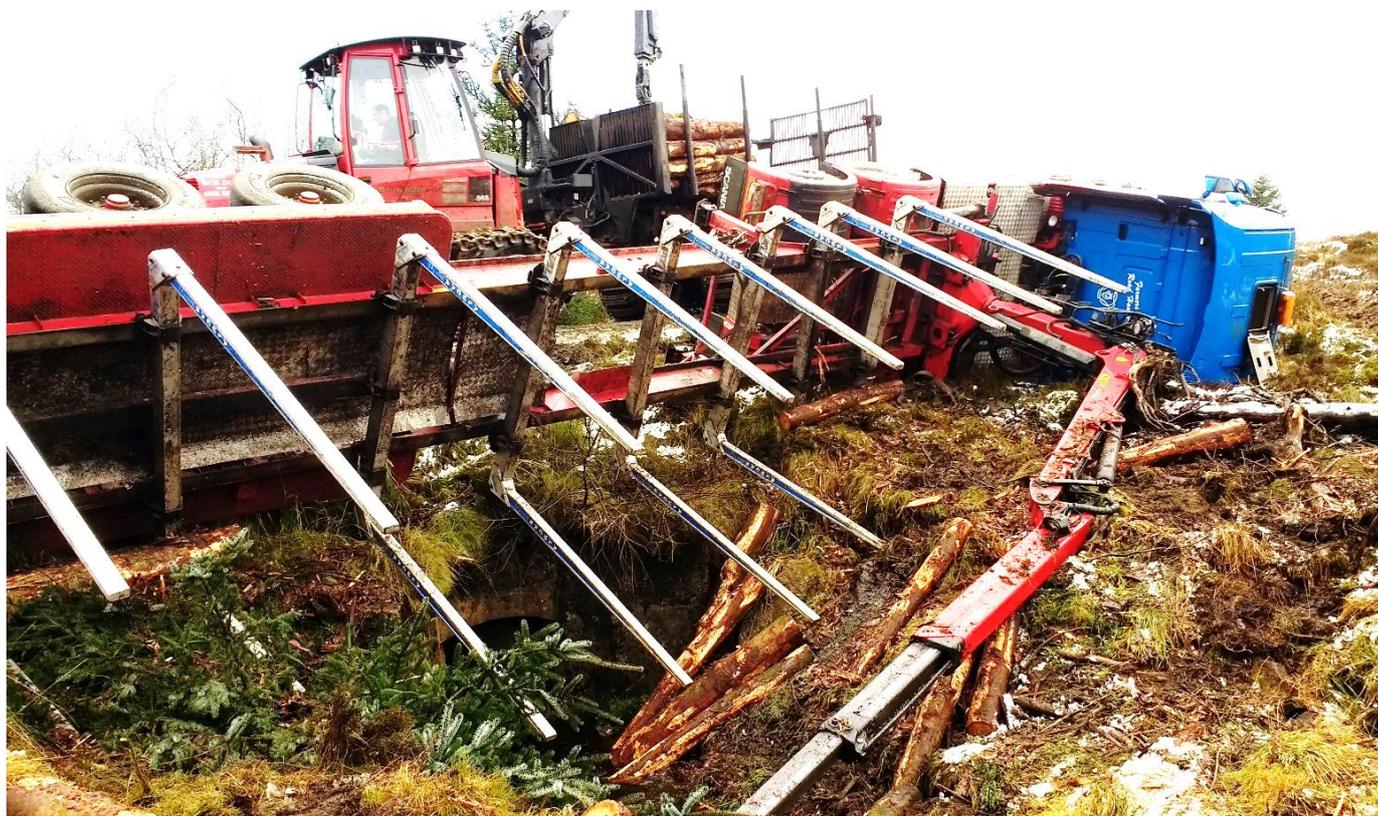
A team of three timber lorries, two crane mounted lorries and one flat bed, entered a large forest complex at 18:30 hours on a winter evening. As they were loading up, heavy snow started to fall. The flat bed was loaded first and left the site, he reported back that the snow was worse on the hill on the way out. On hearing this, the first crane mounted lorry exited the forest with only the front bunk loaded to improve his traction. The third lorry had by now fully loaded. His initial plan was to stay in the forest overnight but he now became concerned that he may be unable to get out in the morning and also decided to leave. More snow had now fallen and the passage of the first two lorries may have compacted the snow on the road. He ran into difficulties while he was climbing up out of a small dip in the road. The lorry lost traction and began to slide to the right, the driver realised that there was nothing he could do to bring the lorry back into control, he braced himself, the lorry went off the edge of the road and overturned.

The driver of the tipped lorry was understandably disorientated and had to be helped out of the cab via the top escape hatch. He had been wearing his seatbelt and sustained no injuries other than general soreness and shock.

Regularly check the weather forecasts for your proposed work area. If heavy snow is forecast, plan your runs accordingly. Snow showers can occur out with these times and will sometimes lie on a forest road overnight but can clear quickly as the temperature rises again the next day. If you are unsure of the safety of the road due to snow, don't enter the forest. If you are in the forest and are unsure of the road quality, check the forecast again. It may be safer to sit tight until it clears. At this location, the snow had cleared off the road by morning.

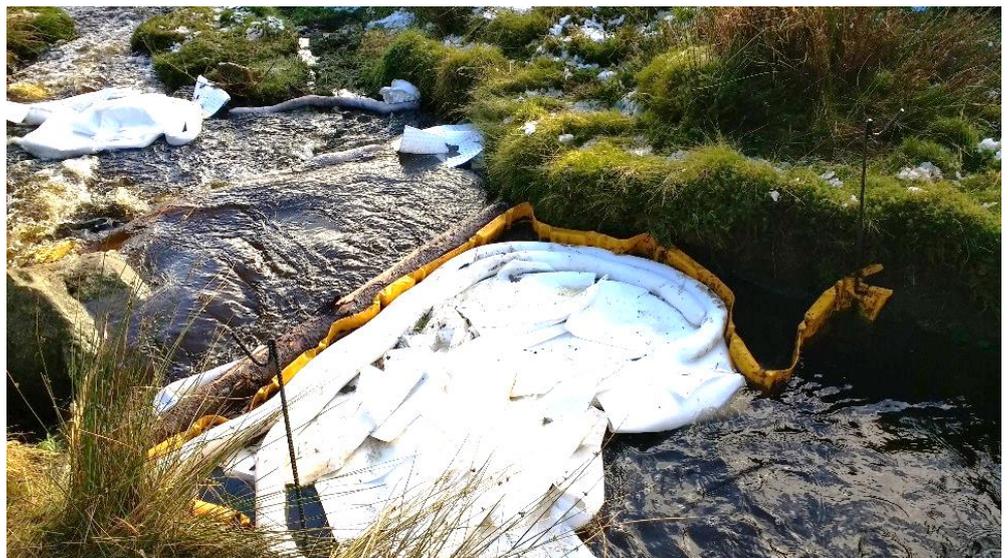
The next morning the harvesting contractors were the first on the scene. They discovered that diesel had been leaking out through the breather hose and was running down the bank into a burn.

They immediately deployed their oil spill containment kits and blocked up the breather hose. They used the forwarder to layout some of the spilt timber to damn the watercourse, slowing the flow down to aid the clean-up. The Forestry Commission and Scottish Woodlands Managers also attended

and aided in the containment and clean up. The Company's oil spill containment specialist contractor was contacted and mobilised to site.

It was estimated that in the region of 50 litres of diesel may have been spilt. It was understood that most of this was recovered and no wider environmental damage occurred.
