# Learning from experience

## A near miss involving pitching a marquee near a high-voltage underground cable

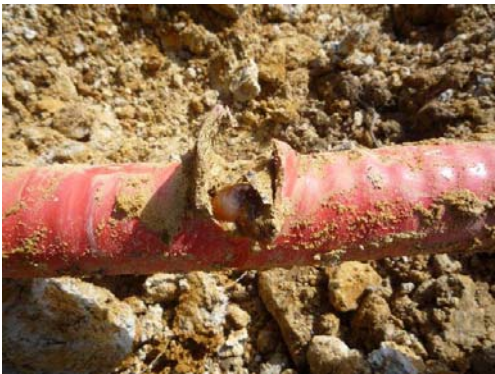
The contractors drove a tent peg through the high-voltage underground cable. It damaged the cable insulation, but did not break/touch the main core of the cable. The power didn't fail immediately, but went off at 6am, one day after the pitching operation, when water in the ground shorted out the power. The contractors did not know they had struck the cable.

Damage to insulation cable by tent peg or spike

Carry out site planning on all work sites that have underground power lines.

- Always hold a pre-commencement meeting.
- Do a site specific risk assessment. Refer to industry guidance, such as Avoiding Danger from Underground Services - HSE guide and Pipelines and gas supply industries FAQ when identifying control measures.
- Communicate with all workers on the site.
- Cat scan and Genny as final control

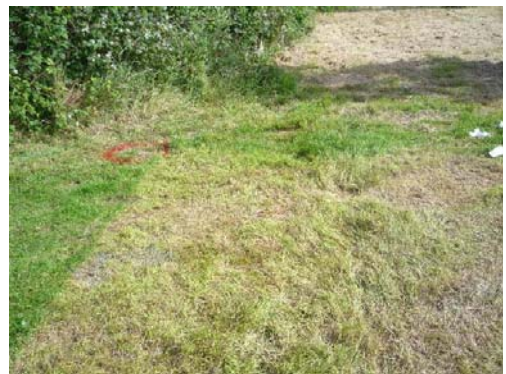
Location of spike hole in the ground

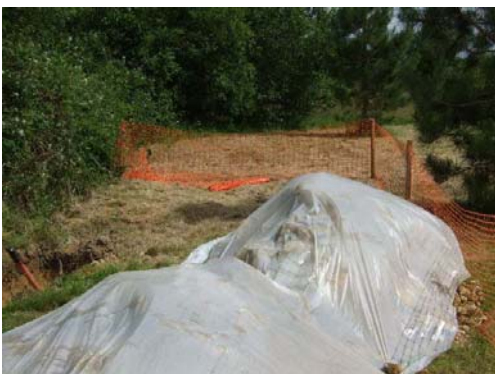
Exploratory dig site to locate damaged cable and repair it
