Harvester brings down farmyard overhead power line

July 2019 (Ref 19.17)

Created by, Scottish Woodlands Compliance Support Team

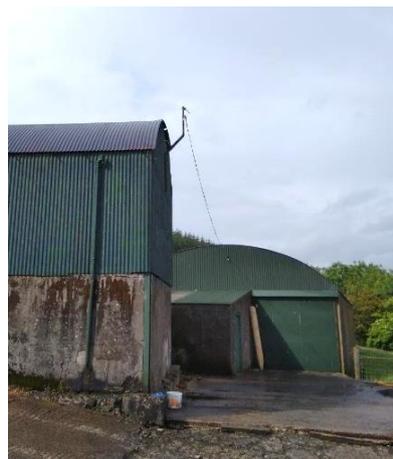
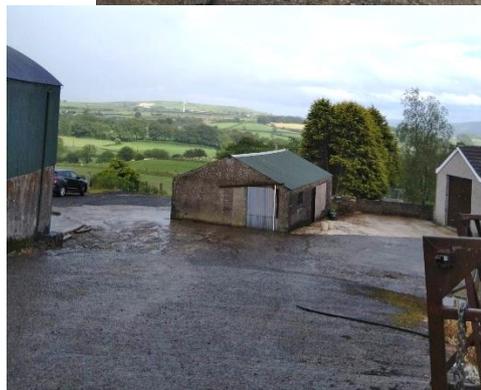
The harvesting team were taking access through a farmyard to a harvesting block. The boom of the harvester snagged a 'private' overhead power line which was running from roof to roof of the farm buildings. The cable broke and fell to the ground.

The powerline had not been seen or identified at the worksite scoping visit and the machine driver did not notice it on the day.

The cable was carrying 230 volts and was coated in an insulating black plastic sheath.

This power line had reputedly been caught and brought down a number of times previously by other machinery accessing the farm.

The power line was insulated in black plastic. While this greatly reduces the likelihood of electrocution if contact is made with it, the insulation may be damaged by the contact or the fall, it may be cracked or worn with exposure to the elements. All outdoor 'insulated' power lines should be treated as 'live' until proven otherwise.

The power line has now been undergrounded.

It is a Forest Industry requirement for all machinery to prominently display within the cab an 'electricity warning sign and the machine heights in its travelling modes'.

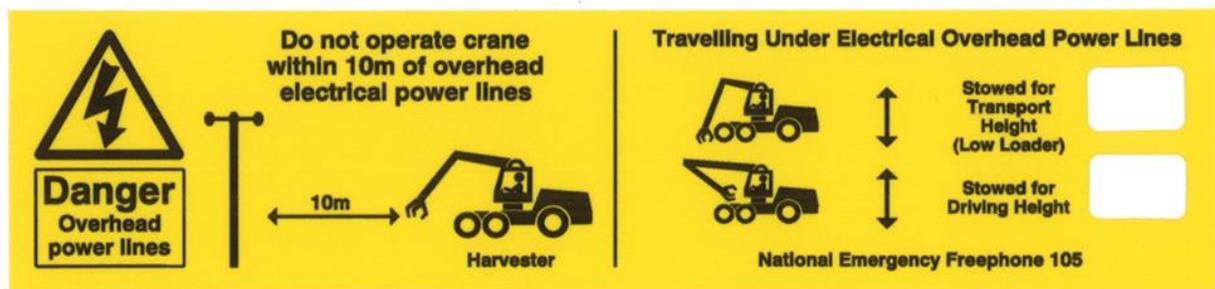
If your machine does not have one, and you would like one for **free**, contact your local Scottish Woodlands Manager or Office, we are holding a stock for harvesters, forwarders, excavators and timber lorries.

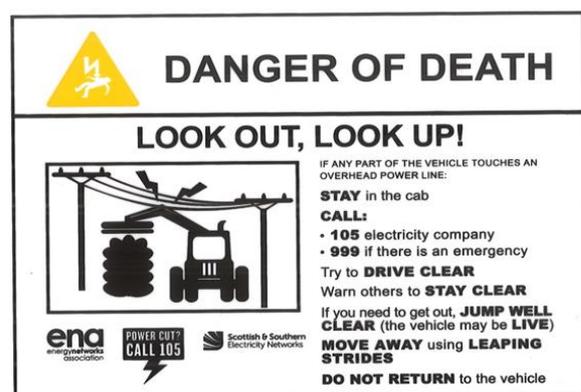
Know what to do if your machine contacts an overhead powerline.

The Energy Networks Association have produced an incident response cab sticker for forestry/farm machinery. If you would like one for your machine, for **free**, contact your local Scottish Woodlands Manager or Office as we are currently holding a stock.
