SAFETY BULLETIN

FEB 2015

Forwarder contacts overhead power line – Dangerous occurrence

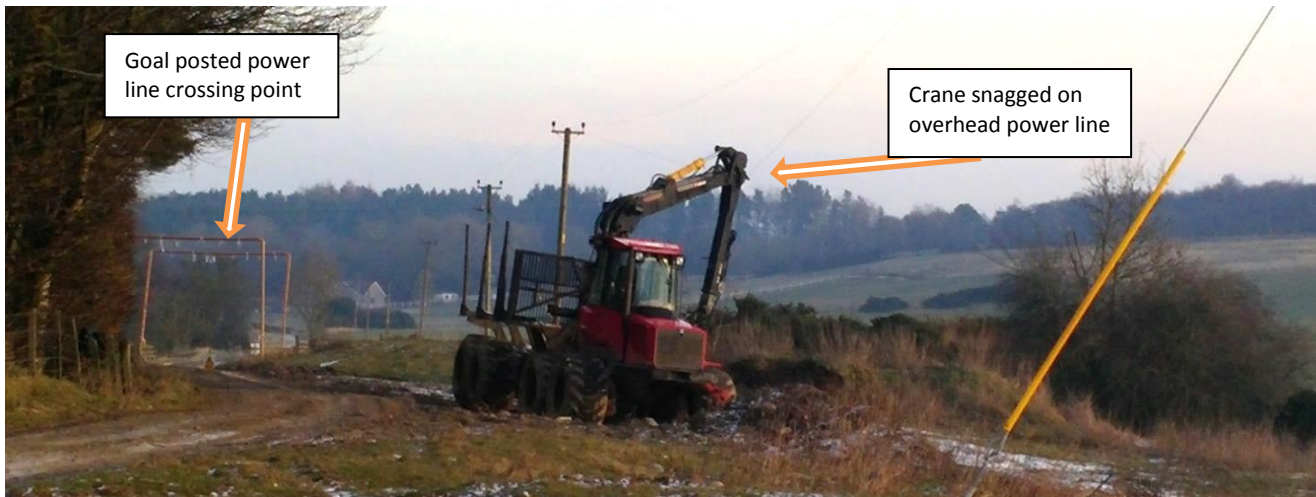
A forwarder was delivered to site on a low loader. The machine was unloaded out with the worksite 600m from the planned unloading/turning area marked on the worksite map. It was delivered at 7:30am in the dark. Under the glare of the machine lights the overhead power lines were not noticed. The forwarder drove off the back of the low loader then into the layby adjacent to the bed of the low loader to unload his band tracks and his fuel bowzers. While lifting off the first set of band tracks the crane of the forwarder came into contact with and snagged one of the overhead 11kv cables.

On seeing sparks a member of the work party shouted a warning to the machine operator. The operator assuming he had broken a hydraulic hose moved to look up out of the machine door, as he touched and opened the door he received two minor electric shocks, but was uninjured.

Realising the power cable was possibly snagged, the machine operator had the presence of mind to not drive the machine away, which could have broken and dragged the cable to the ground, greatly increasing the level of danger. The area was made safe and the incident was immediately reported to the network provider, who attended the scene, de-energised the line and disentangled the cable. The power cable itself was undamaged.

The FWM worksite scoping visit had identified a safe machine unloading area, this had been marked on the worksite map and detailed on the documentation. Any proposed deviation to the work plan should be agreed with the FWM - there may be safety or other factors of which you are not aware. If your machine does come into contact with an overhead power line, always follow the guidance in the FISA 'Look up, Stay alive' leaflet.
