# RED ALERT

## Fall From Height Incident

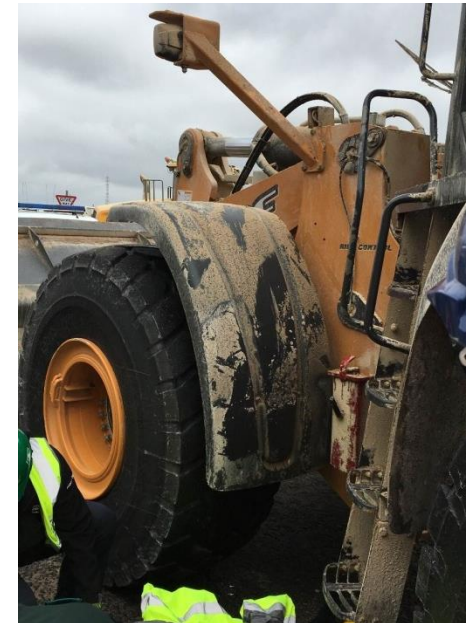
Be aware of a recent incident whereby an Operative has fallen some 8 feet whilst attempting to clean the windscreen of a loading shovel. Dash-cam footage obtained from a nearby tipper wagon shows the fall. The footage clearly demonstrates that although the Operative has sustained a painful head injury, his safety helmet helped to prevent a more serious injury.

**IN THIS INSTANCE THE NEED TO WORK AT HEIGHT SHOULD HAVE BEEN COMPLETELY ELIMINATED BY THE USE OF A LONG HANDLED BRUSH OR EQUIVALENT**

**Do not, under any circumstances climb on, or up plant and machinery without them having safe and correct access ways, and then, only after fully assessing the hazards and risks**
